D E N N I S K O W A L A R C H I T E C T S
52 West Main Street • Somerville • New Jersey 08876 • Telephone 908-231-0201 • Fax 908-218-7979

25 April 2014

Re: Zion Lutheran Church # 1407
Written Report and Recommendations

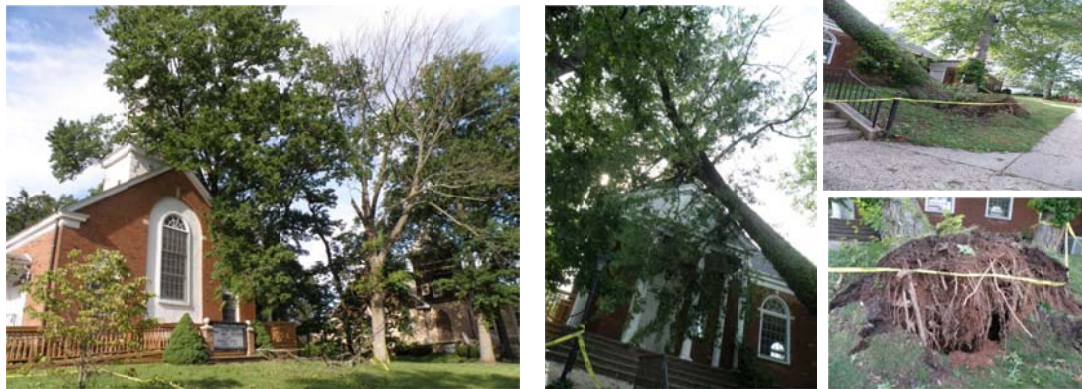
The committee then reported that a major tree had fallen during a storm and was stopped from hitting the ground only by landing on the Church building. Members of the congregation then supplied to this author photos of the fallen tree. The tree appears to be of 24” caliper and can be seen resting on the East roof of the Church Building. The photos were taken by congregant, and then Building Committee member, Therese Bera after the 28 August 2011 Hurricane Irene storm.

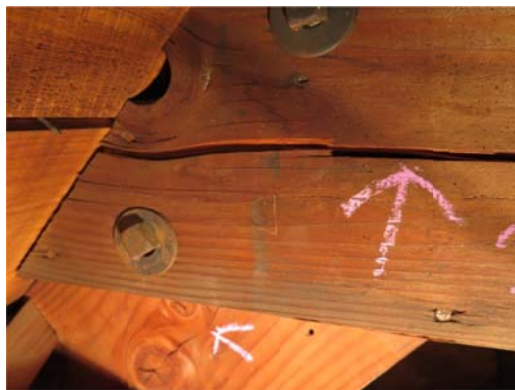
Truss #2 Horizontal member split Photo 130

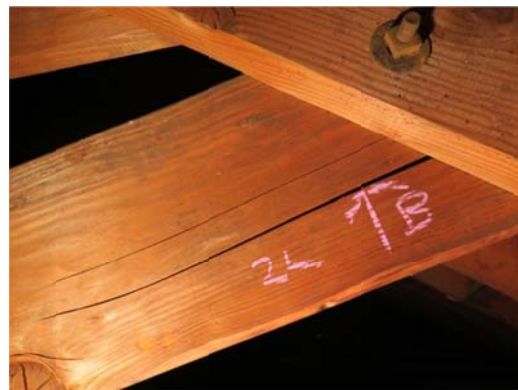
Truss #2 Fracture goes all way through Photo 98

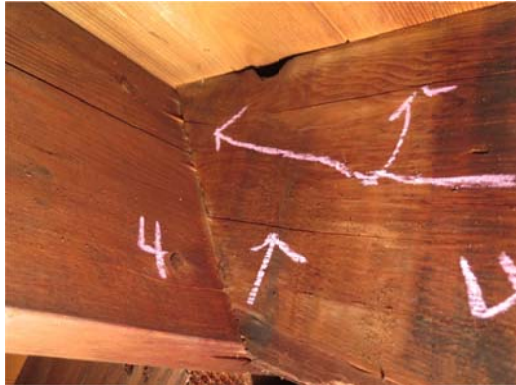
3. The wood ridge was fractured along its length in the area of the compromised trusses. This is an unusual condition in that the ridge in this case is somewhat “non-structural”. It appeared that twisting moment from the upper truss member was peeling the bottom of the ridge member away from the top of the ridge member much like the lever action of a can opener. While the fractured ridge was not the major structural concern, the fact that this much stress and movement had occurred is a warning sign and a major concern.
4. When some fractured trusses were discovered, it was enough evidence to determine that the plaster cracks were not simply cosmetic (which was the purpose of the initial visit).

Truss #4 Ridge member split Photo 137

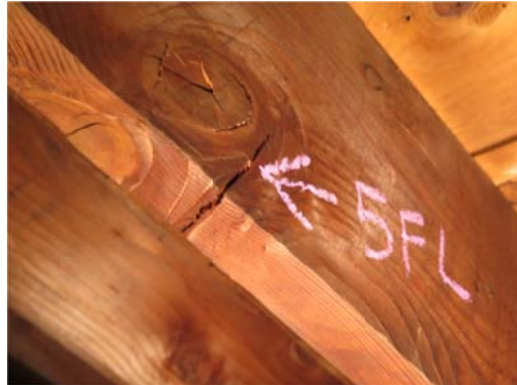
Truss #5 check at knot Photo 182

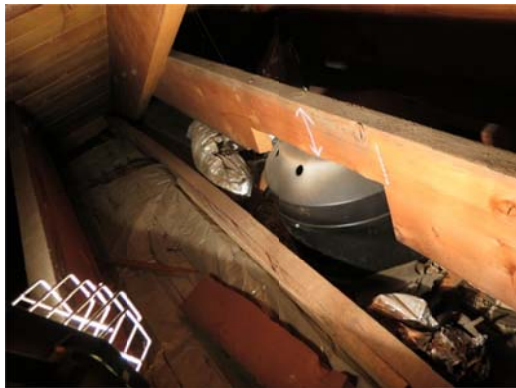
1. The bottom chord of one of the roof trusses had been coped out in two locations to accept the housings for ceiling installed downlights. Although this is not an acceptable practice and must be structurally repaired, it could not be the sole cause of the outside walls bowing as the weakening of the chord did not yet result in a complete shear.
2. At least five trusses had fractures of the wood members at or near the bolted joints of the timber members. The fractures appeared to travel all the way through the truss members. Fractures are irreversible, compromise the connective value of the bolted connections and change the way the stresses were designed to move through the truss. When the fracture

Truss #5 improper notching Photo 176

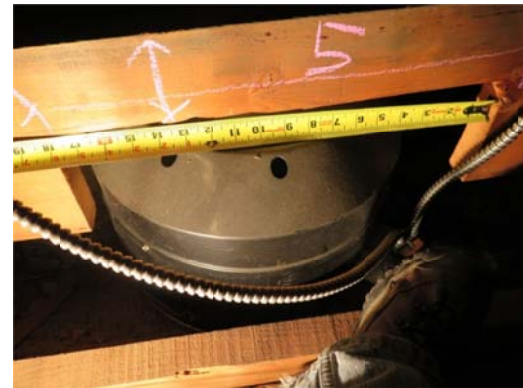
Truss #5 improper notching Photo 175

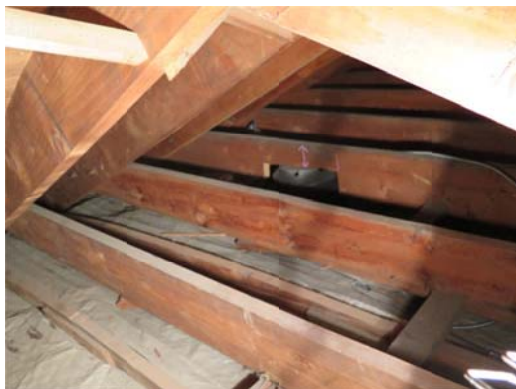
Photo 228 and 161 show the beginning of the truss tails descending out of observable view. The lowest connection points near outside walls rarely had splits, cracks or fractures.

Lowest members mostly intact Photo 228

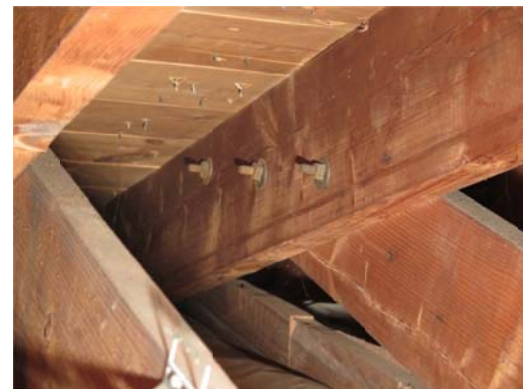
Lowest members mostly intact Photo 161

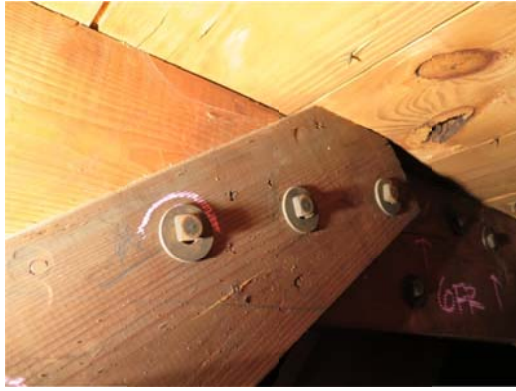
Truss 6 Loose bolted connection Photo 191

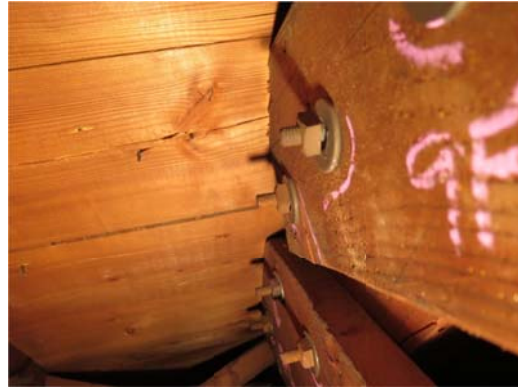
Truss 9 Loose bolted connection Photo 241

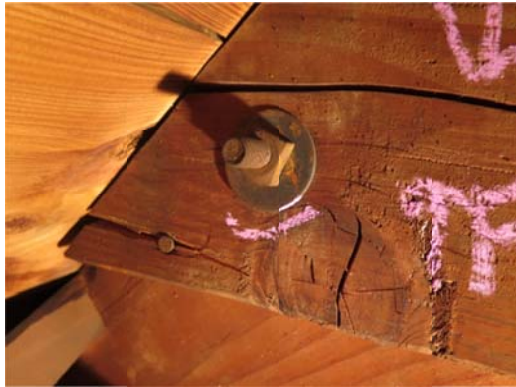
Truss 9 Loose bolt, fractures Photo 243

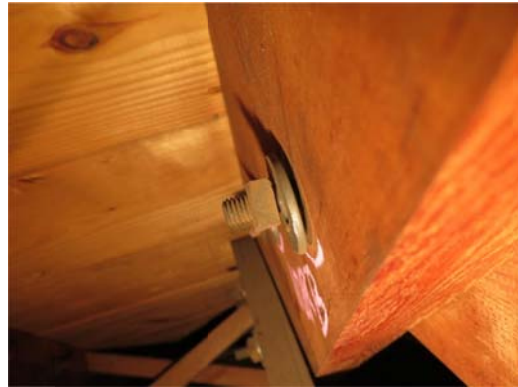
Truss 10 Loose bolt, fractures Photo 215

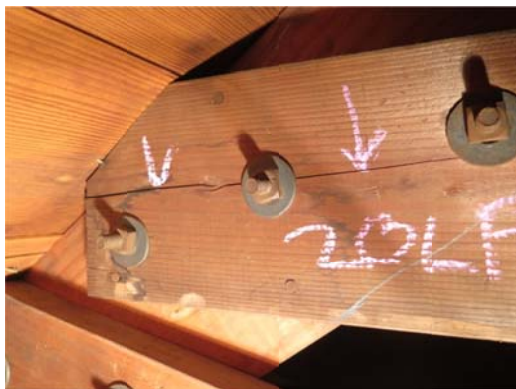
Truss 20 Full fracture through bolt Photo 286

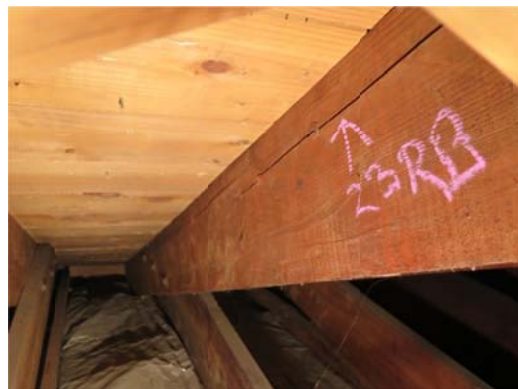
Truss 23 Fractured length Photo 291

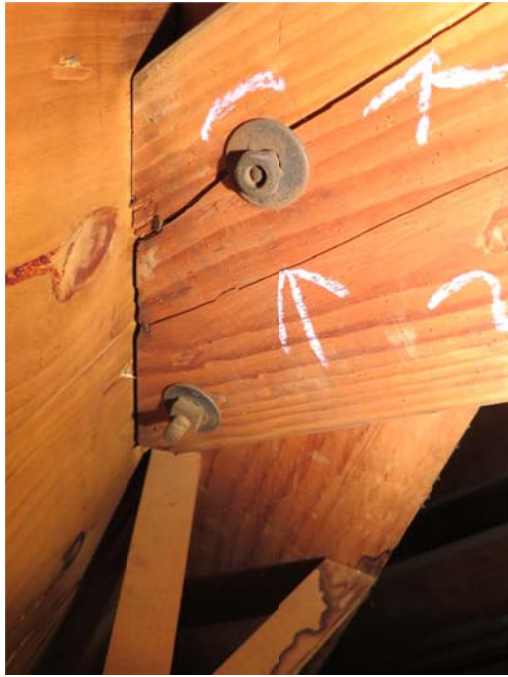
Truss 26 Full fracture through bolt Photo 308

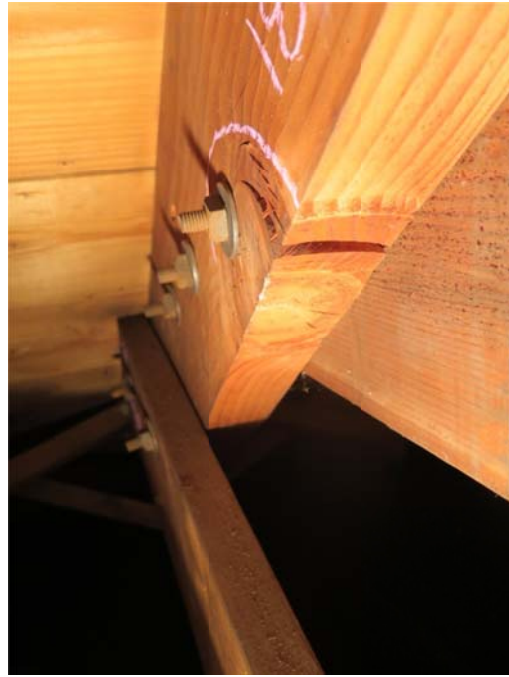
Truss18 Normal knot fracture Photo 280

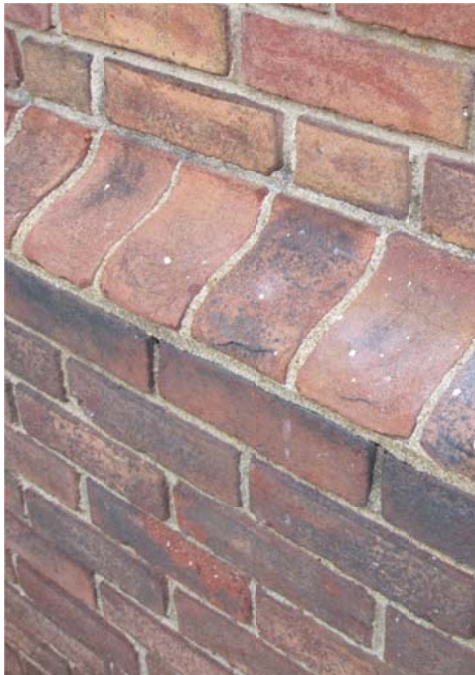
Exterior masonry jointing is crack-free

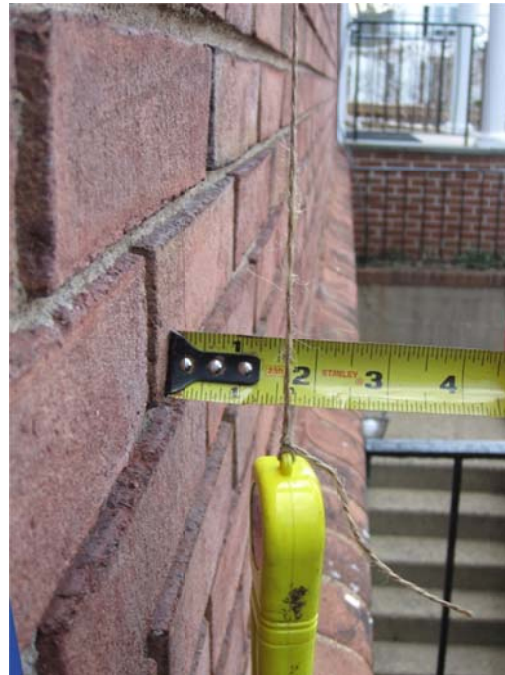
Upon closer observation, it could be seen that the exterior long walls were slightly out of plumb with the East and West walls appearing further out from center than the base of the walls. There were no horizontal stress fractures related to the bowing. It could not be determined from an exterior examination if the walls were originally constructed out of plumb or if they had moved from an original plumb condition. Interior painting evidence suggested that interior moldings had separated from their original location which would support a theory that the exterior masonry East and West walls had indeed moved outward at the eaves. It was determined it would be necessary to check the trusses above the two major crack locations to see if there was any evidence of movement. The building committee in attendance was given the initial findings, orally, after some of the trusses above the cracks were observed first hand.

Exterior walls bow out 2"

Exterior Braces could be buttressed against the outside wall to stabilize the building. Braces would obstruct immediate construction of an addition or expansion of lower level wells. A scaffolding or stabilization contractor can rent or provide lateral bracing and install it quickly. All work requires drawings and permits.

Alternately, a structural channel could be applied to the East and West building fascia's and tied together by cable or rods through the Sanctuary. Since the exterior walls are masonry and it is not known whether they contain vertical and horizontal reinforcement (original drawings don't specify), pulling on the top of the bearing walls (to bring them back in) could simply snap a few courses off the top rather than uniformly pulling the entire wall. It may be wiser to only relieve the horizontal component of stress now being forced into the wall from the sagging trusses rather than to plumb the walls again. This would reduce the possibility of exterior cracks opening in the brick jointing. It is normal practice to leave well enough alone in terms of plumb.
