D E N N I S K O W A L A R C H I T E C T S
52 West Main Street • Somerville • New Jersey 08876 • Telephone 908-231-0201 • Fax 908-218-7979

25 April 2014

Re: Zion Lutheran Church # 1407
Written Report and Recommendations

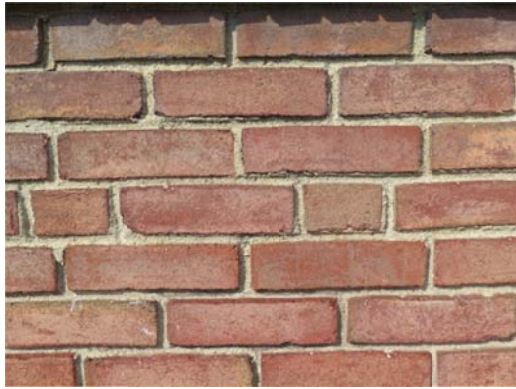
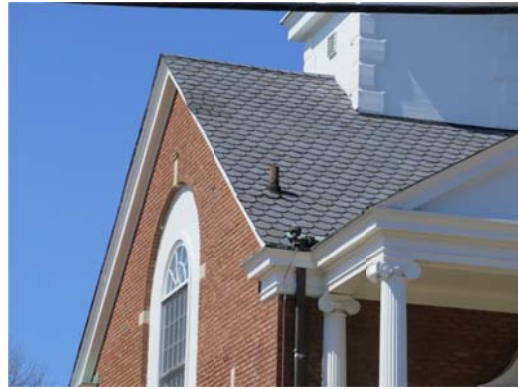
1. There were interior vertical cracks in the wall plaster at several locations.
2. Some vertical cracks spread to the ceiling and extended laterally.
3. There did not appear to be water infiltration associated with the cracks.

4. The exterior brick appeared solid, in good condition, and with no horizontal, vertical, or stepped fractures.
5. The foundation appeared to be poured concrete; and where observable, it appeared to be solid, devoid of fractures, and devoid of spawling.

6. There appeared to be no sign of settlement of the foundation.
7. There appeared to be no sign of settlement or water collection at the grade surrounding the building.

8. There appeared to be no openings, missing shingles or deformations of the roofing, ridge line or eaves.
9. There appeared to be no unusual deflection of the Sanctuary floor and no recent separations of the baseboard and floor. (A ½" wide gap around the baseboard was consistent everywhere and appeared to be built this way and not settlement).

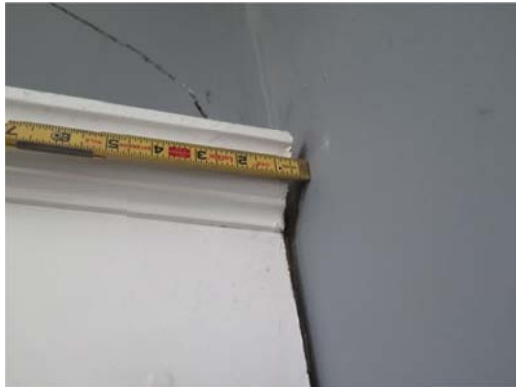
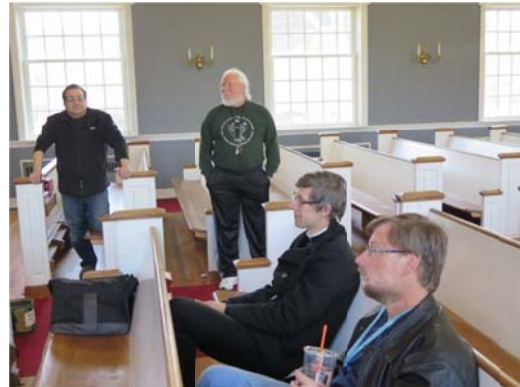
Upon closer observation, it could be seen that the exterior long walls were slightly out of plumb with the East and West walls appearing further out from center than the base of the walls. There were no horizontal stress fractures related to the bowing. It could not be determined from an exterior examination if the walls were originally constructed out of plumb or if they had moved from an original plumb condition. Interior painting evidence suggested that interior moldings had separated from their original location which would support a theory that the exterior masonry East and West walls had indeed moved outward at the eaves. It was determined it would be necessary to check the trusses above the two major crack locations to see if there was any evidence of movement. The building committee in attendance was given the initial findings, orally, after some of the trusses above the cracks were observed first hand.

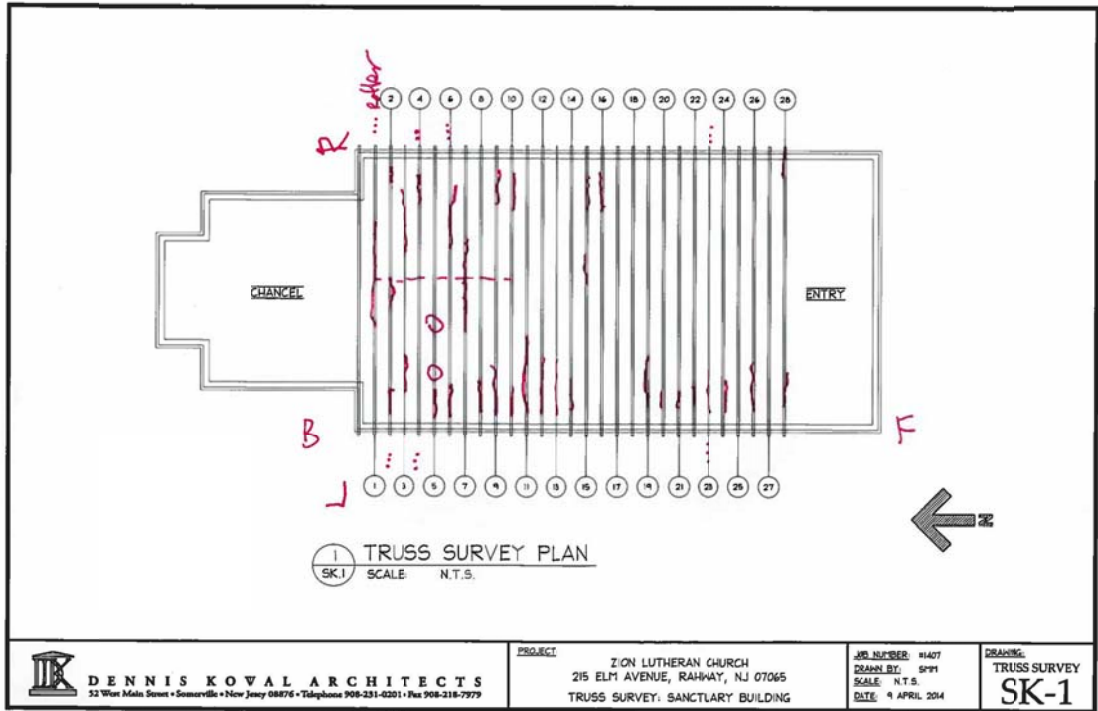
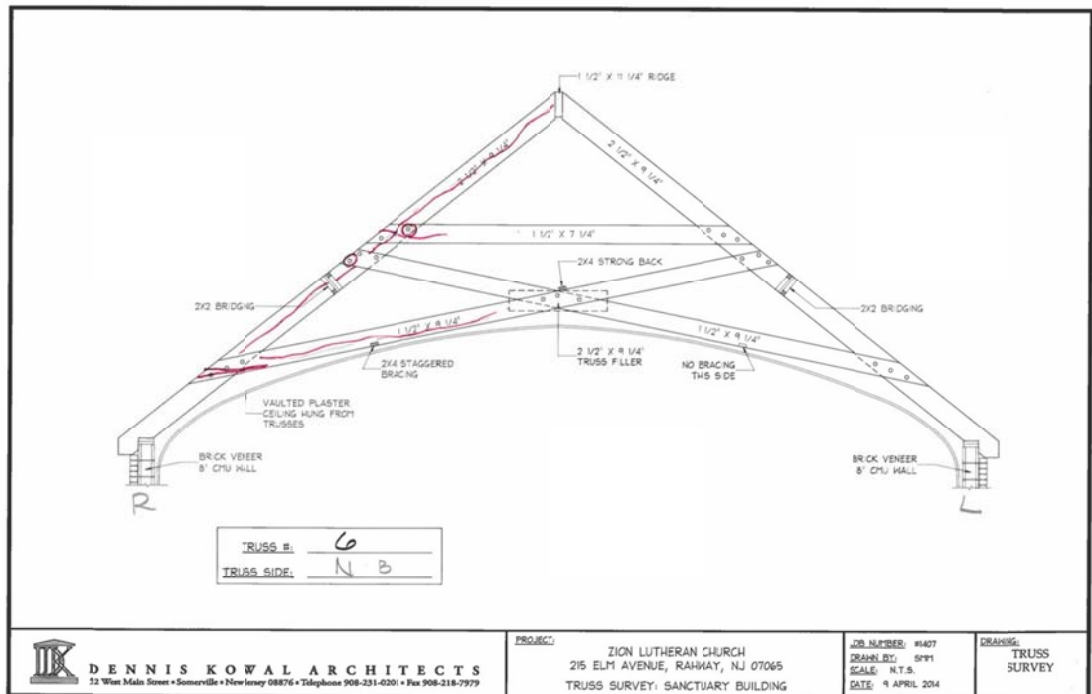
The following represent typical depictions. All trusses numbered were surveyed. Only those faces with findings were drawn and labeled.
